# UNDERWATER BRIDGE INSPECTION REPORT

STRUCTURE NO. 5804

BIG FORK RIVER

DISTRICT 1 - KOOCHICHING COUNTY

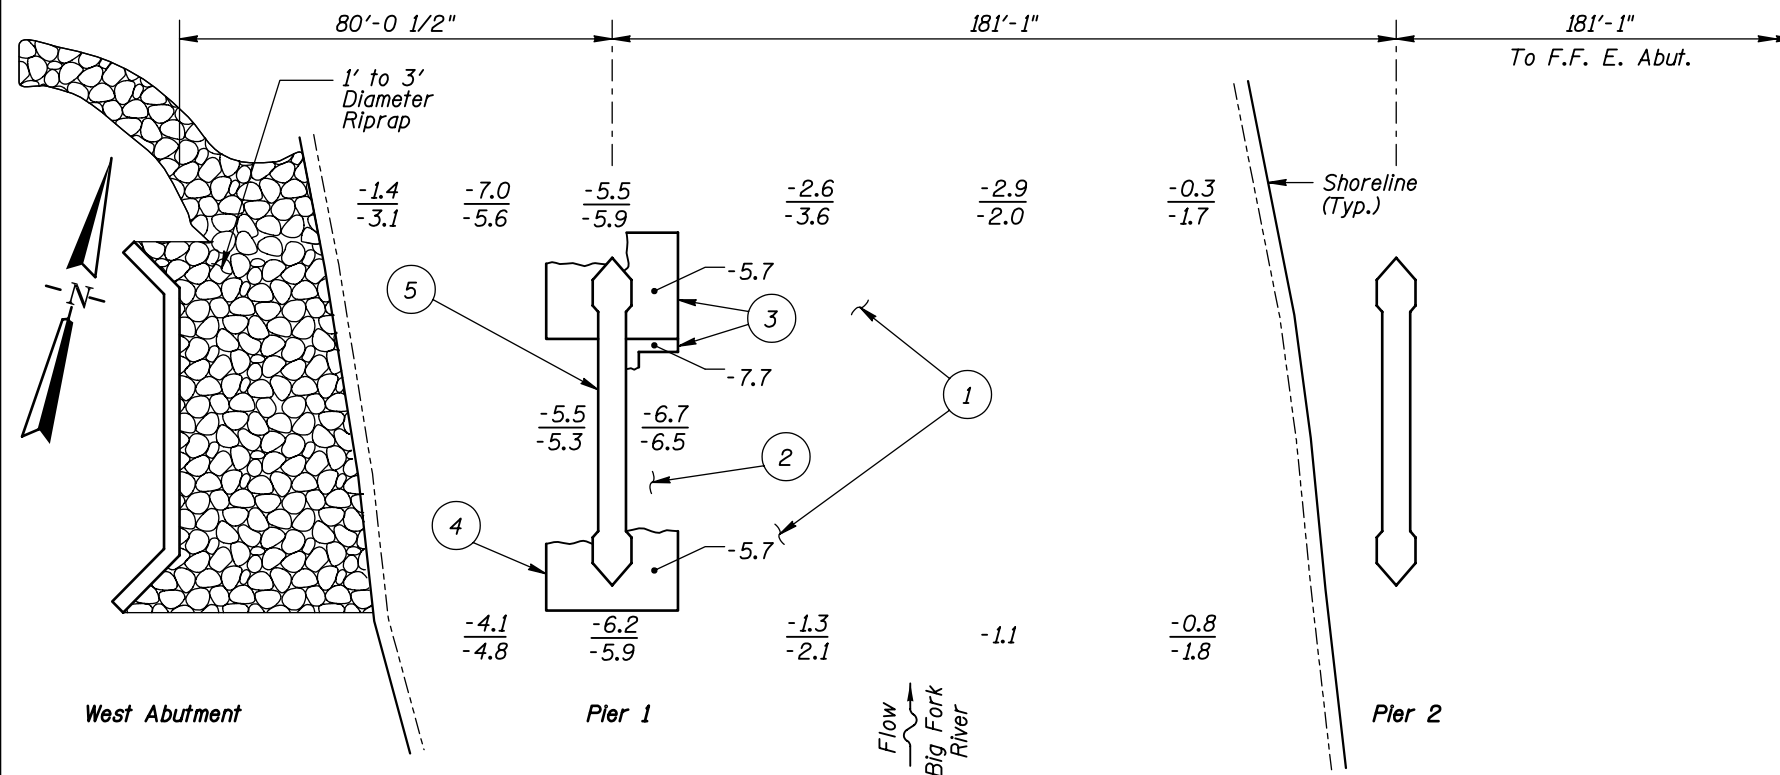
#### INSPECTION AND SOUNDING PLAN

- (A) There was footing exposure at the upstream and downstream noses of Pier 1. The maximum vertical exposure of the footing was 3 inches on the second footing step (seal) (2 foot, 3 inch total footing exposure including first footing step) found at the upstream east corner of the downstream portion of the footing. The vertical face exposure was caused by a 2 to 3 foot deep scour depression located adjacent to the footing.

- The channel bottom material within 10 feet of the pier typically consisted of sand with gravel and scattered riprap with up to 3 to 6 inches of probe rod penetration.
- The channel bottom material between the footings consists of softer sand infilling.
- Footing exposure around the downstream nose with second step (seal) of footing exposed at the southeast corner with 3 inches maximum vertical exposure. Full 2 foot exposure of first step of footing.
- Footing exposure around upstream nose with 6 inches maximum vertical exposure at the upstream end.
- Concrete of pier shaft and footing was typically in good condition, with light scaling having 1/8 inch to 1/4 inch penetration, from 3 feet above the waterline to the mudline.

- (A) Monitor the extent of the scour and footing exposures during future inspections, and if found to be significantly progressing, then remedial measures may be warranted.
- (B) Reinspect the submerged substructure unit at the normal maximum recommended (NBIS) interval of five (5) years.

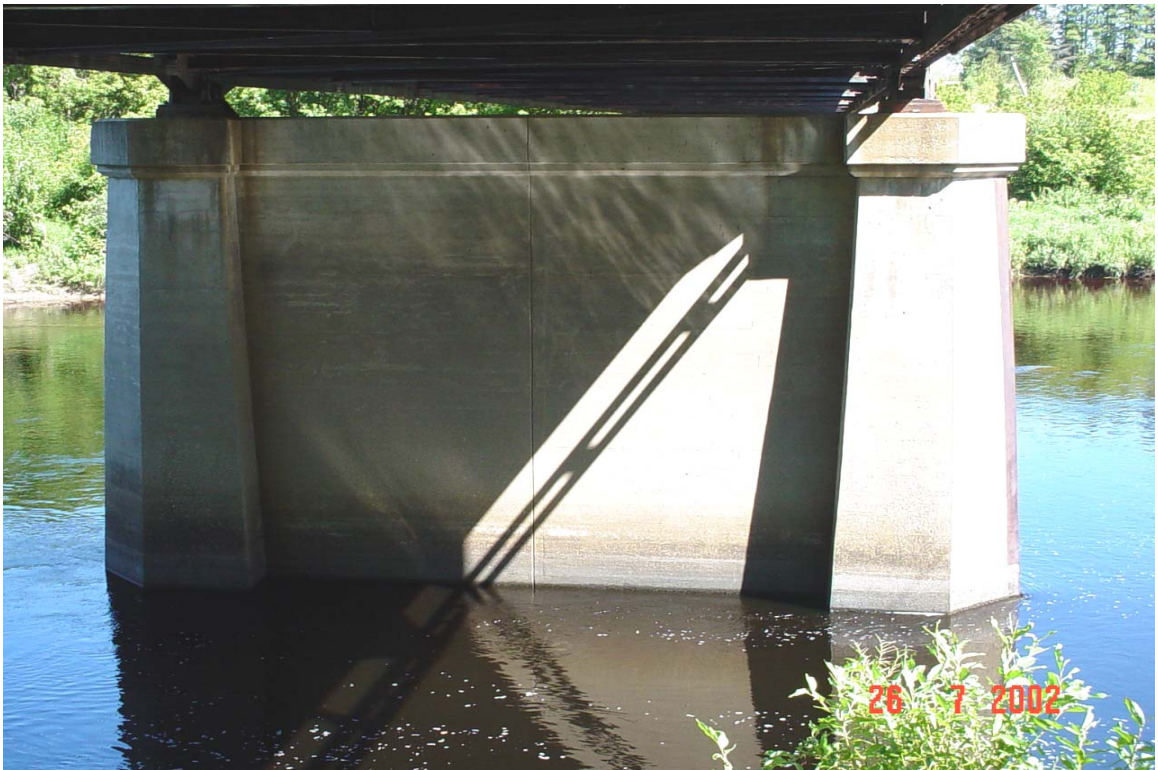
Photograph 2. View of Pier 1, Looking East.

REMARKS: The concrete of the shaft and exposed footings was in good and sound condition with light scaling from 3 feet above the waterline to the mudline. Both column footings were partially exposed. The upstream end of the upstream footing had a maximum vertical exposure of 6 inches. The full height of the first step (2 feet) of the downstream footing was exposed with the second step (seal) exhibiting a maximum vertical exposure of 3 inches.

Monitor the extent of the scour and footing exposures during future inspections, and if found to be significantly progressing, then remedial measures may be warranted.

Reinspect the submerged substructure at the normal maximum recommended (NBIS) interval of five (5) years.

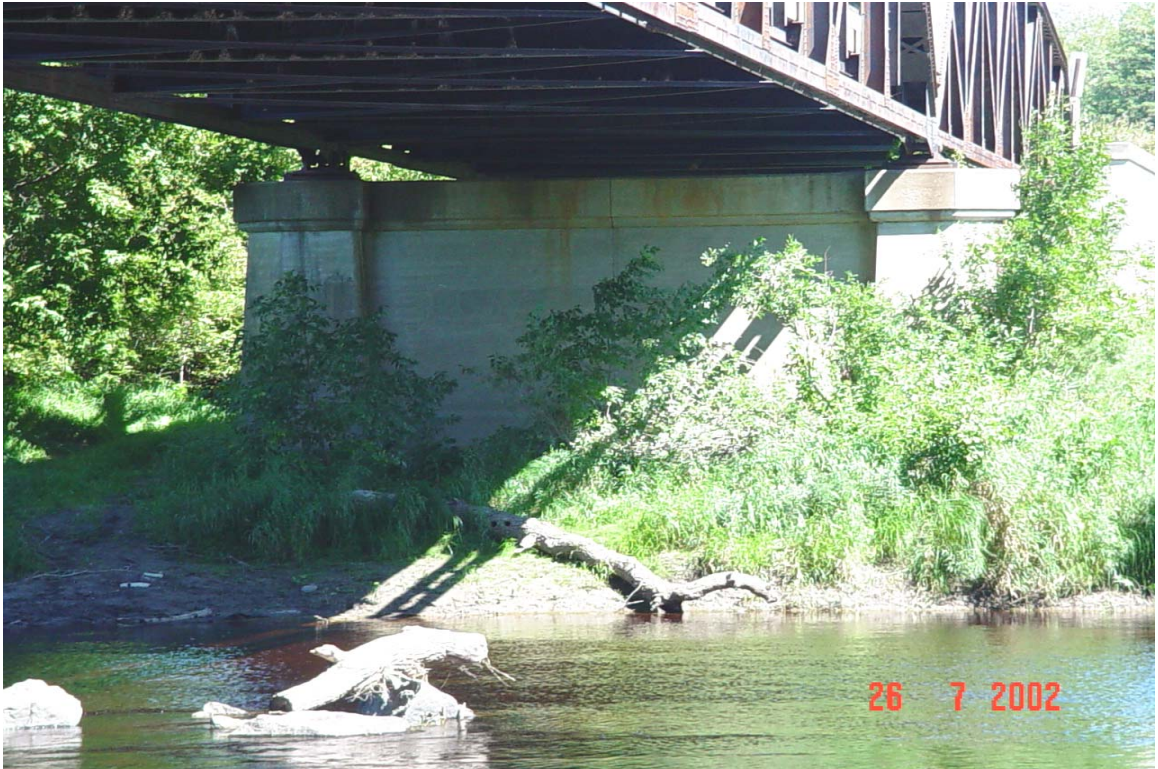
Photograph 3. View of Pier 2, Looking Northeast.

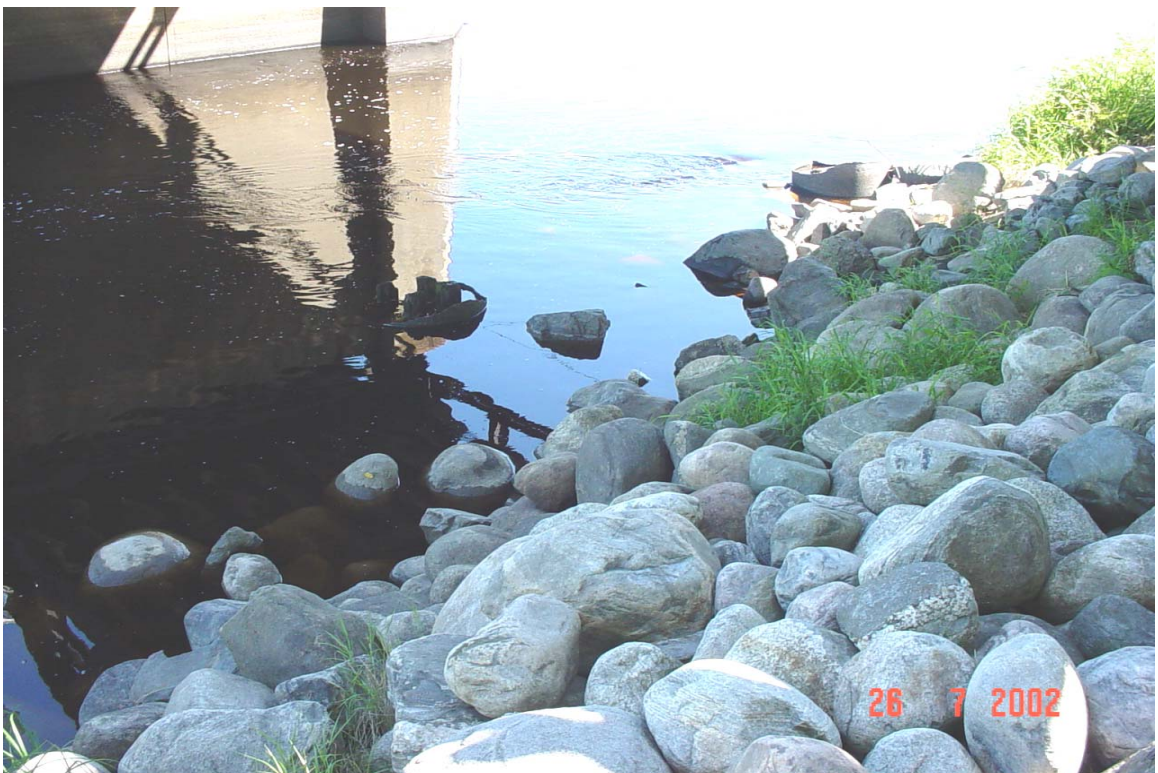
Photograph 4. View of Shore Protection on the West Bank, Looking South.
